Full Mouth Rehabilitation of a Bruxer with Severely Worn Dentition Using All Ceramic Zirconia Crowns – A Case Report

Ashish.R.Jain^a MDS MD.ACU.VARMA, Sindhu .P^b BDS

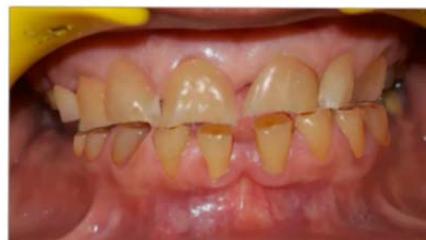
Figure 1: Initial oral examination frontal views

A 55year old male patient reported to private clinic with a chief complaint of difficulty in chewing due to short teeth, speech problem and poor facial appearance. On the first appointment patient's medical and dental history was recorded. Patient revealed nocturnal/daytime grinding and clenching of his teeth. Extra-oral examination was done and patient had muscle tenderness and pain in the temporomandibular joint. Intra-oral examination revealed severe generalized attrition and occlusal wear facets (Figure 1). Patient presented a worn dentition and inadequate length to width proportions of maxillary central incisors. Diagnostic radiograph was taken (Figure 2). Patient was diagnosed with nocturnal/daytime bruxism.

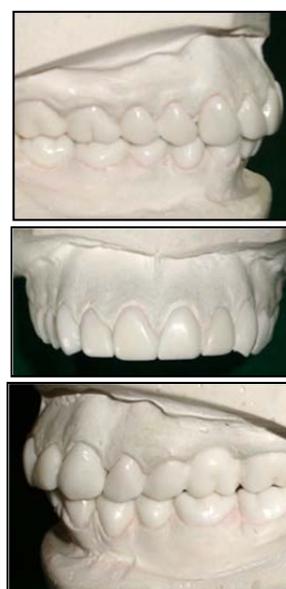
Figure 3: Diagnostic wax-up was done with the new VDO that was obtained by using the occlusal splint. A: Left lateral, frontal and right lateral views. B: Maxillary occlusal view. C: Mandibular occlusal view.

5. Diagnostic wax-up was done with the new VDO that was obtained by using the occlusal splint (Figure 3).
6. Root Canal Treatment (RCT) was performed for all remaining teeth, with post and core build up for 11, 12, 13, 21, 22, 23, 24 and 45.

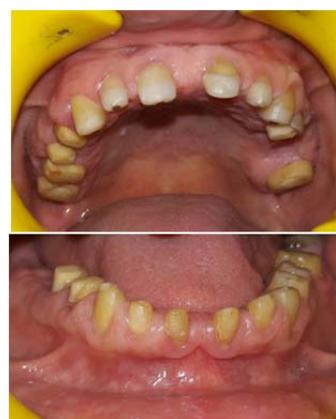
Figure 4: Tooth Preparation

7. Tooth preparation was done in all teeth for all ceramic Zirconia crown (Figure 4). Fixed interim prosthesis (Provisional Restoration) was cemented using temporary cement at the desirable VDO (Figure 5).

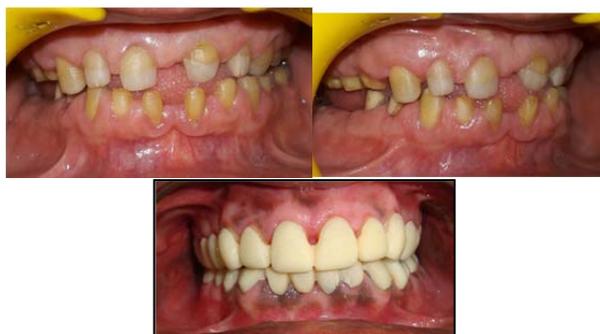
Figure 5: Evaluation of diagnostic provisionals after gingivectomy .

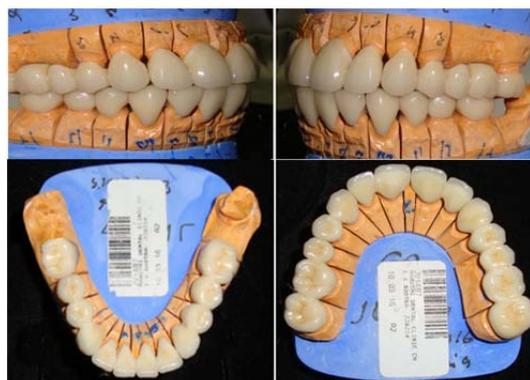
Figure 6: Finished All Ceramic Zirconia restorations. A: left lateral and right lateral view

9. Final preparation was done for definitive oral rehabilitation. Definitive impression was made using polyvinyl siloxane material (Aquasil, Dentsply, Germany). All Ceramic Zirconia restorations were fabricated (Figure 6).

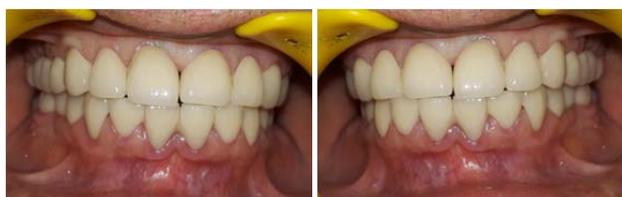
Figure 7: Definitive restorations were luted. A: left lateral and right lateral view

10. Definitive all ceramic Zirconia crowns were luted to the tooth preparation thus providing mutually protected occlusion (Figure 7). Patient was monitored for 24 hours and necessary occlusal corrections were done. Oral hygiene instructions were given to the patient. A protective occlusal splint was given to the patient to prevent further damage.
