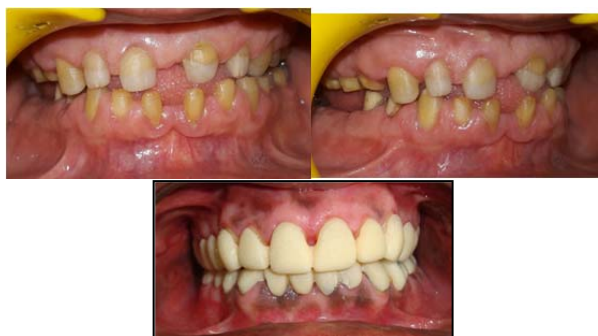
Figure 5: Evaluation of diagnostic provisionals after gingivectomy .

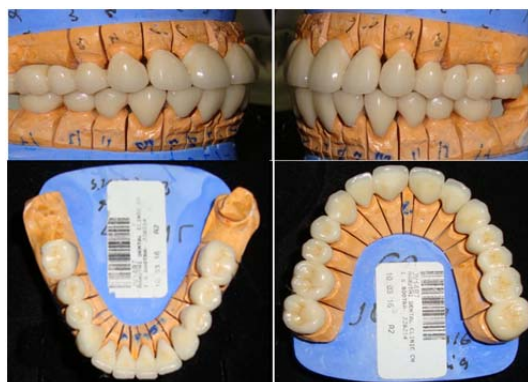
Figure 6: Finished All Ceramic Zirconia restorations. A: left lateral and right lateral view

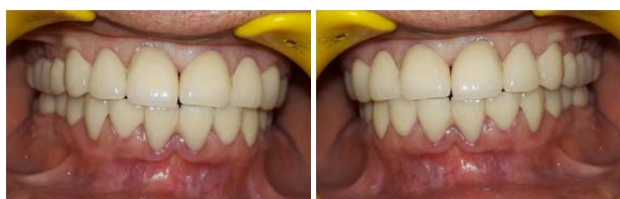
Figure 7: Definitive restorations were luted. A: left lateral and right lateral view
